Materials and Processes Engineering's Role in the Reconstruction and Failure Analysis of The Space Shuttle Columbia

Rick Russell

NASA Orbiter Project Support Office

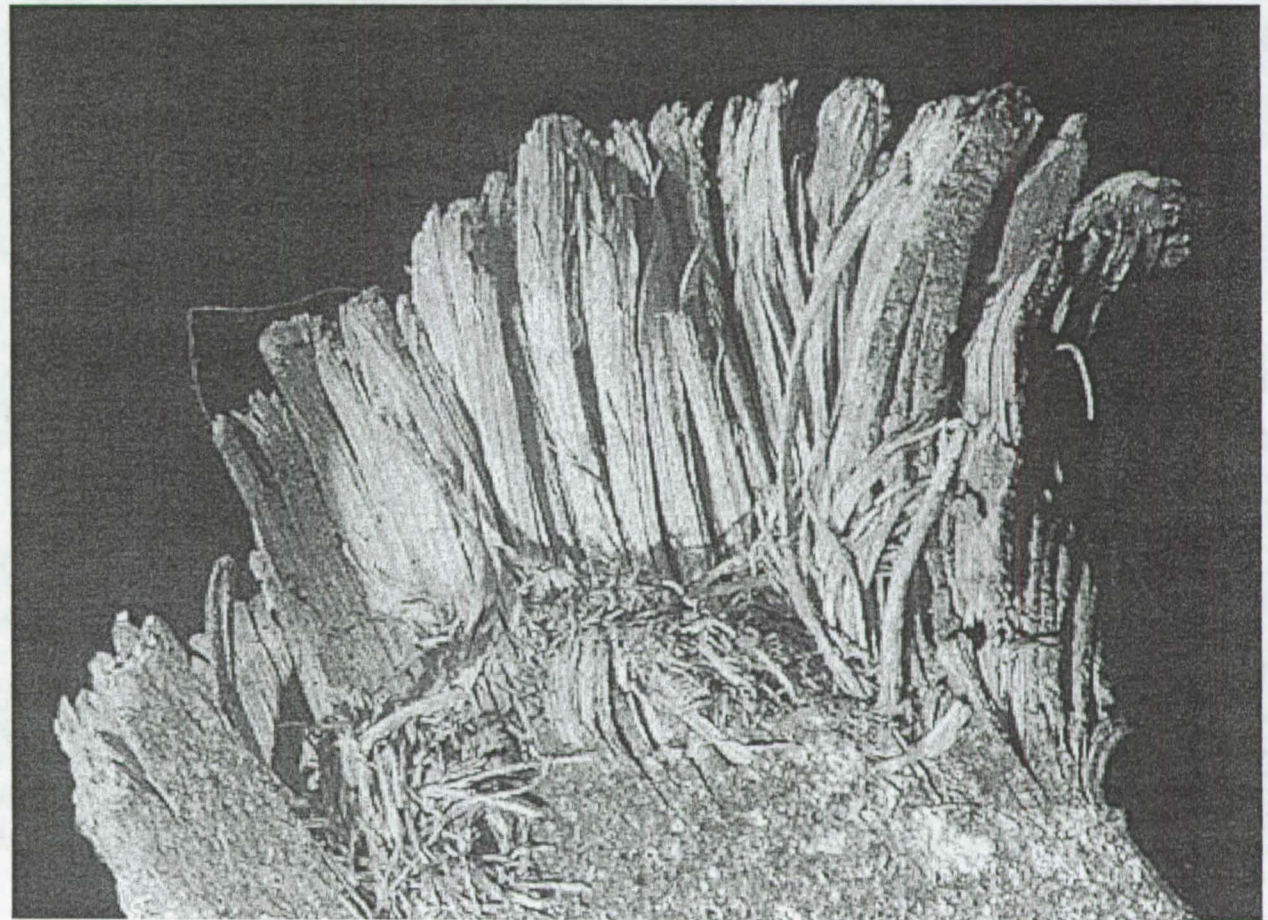
Aluminum Pathfinder

- Intergranular fracture primary failure mode

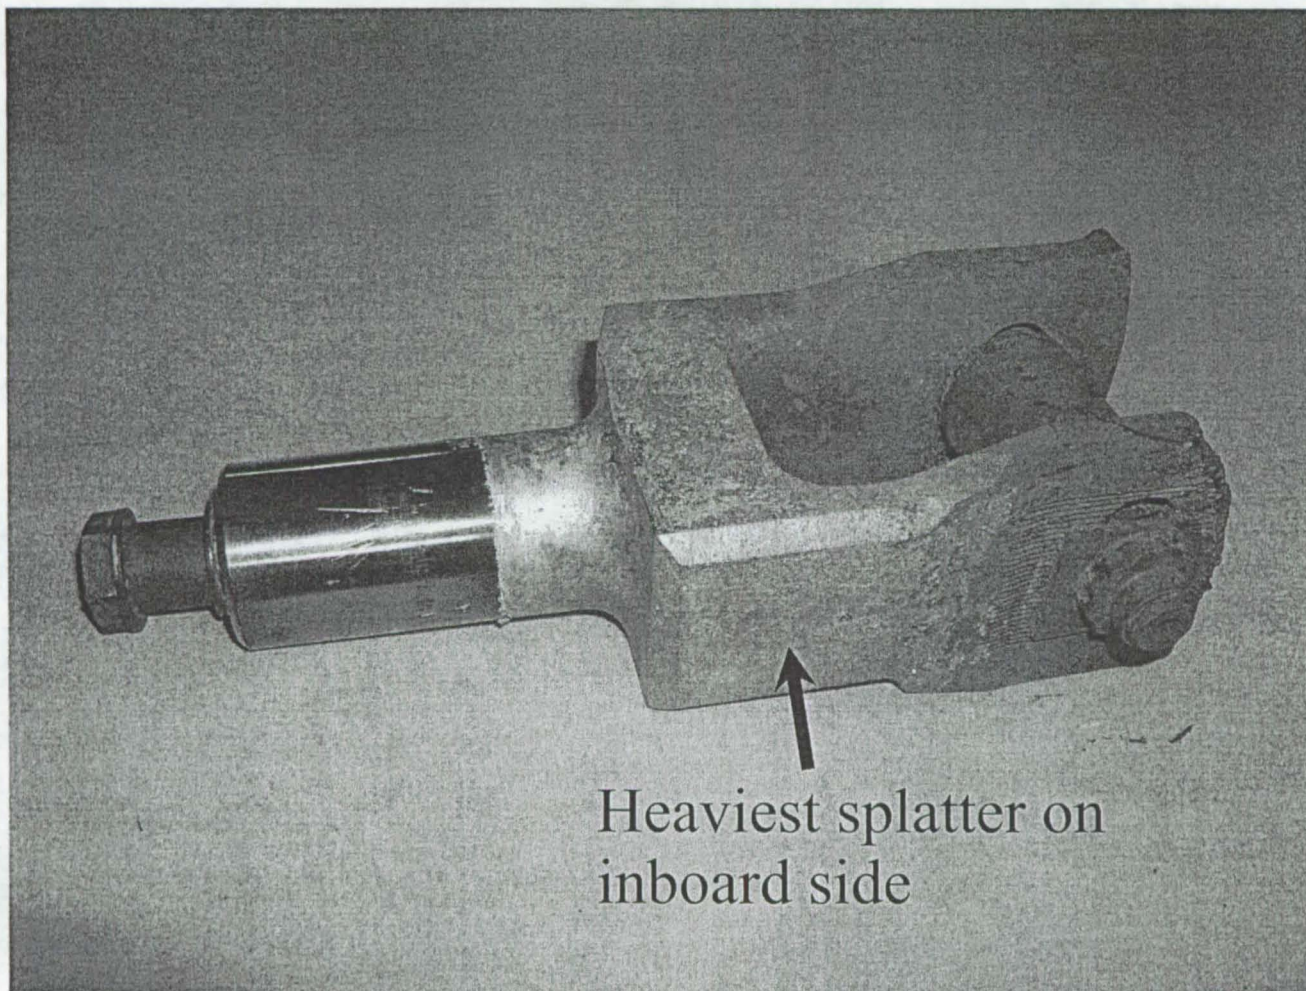
Early Analysis - Main Landing Gear Uplock Roller

Heaviest splatter on
inboard side

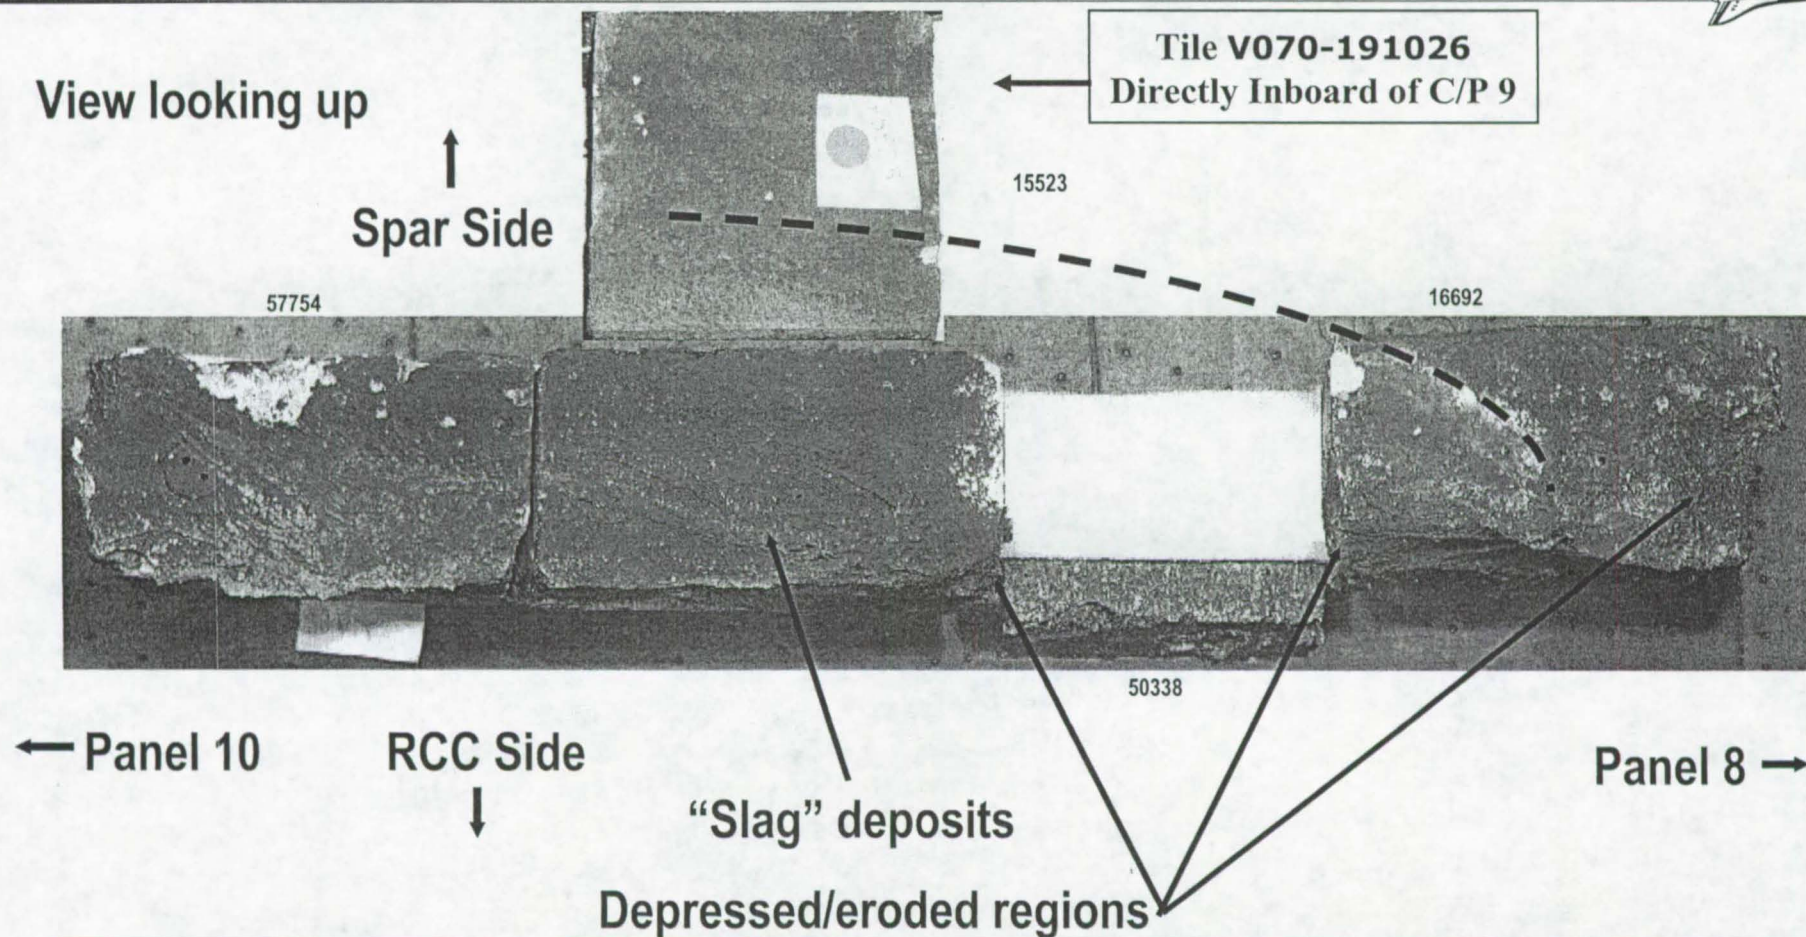
Reconstructed View of LC/P 9 Tile with I/B Tile

Flow Patterns Indicates C/P 9 Was Not Dropped Down Into Flow
Open question: Location of Plasma Flow From Panel 8 to tiles on 9?

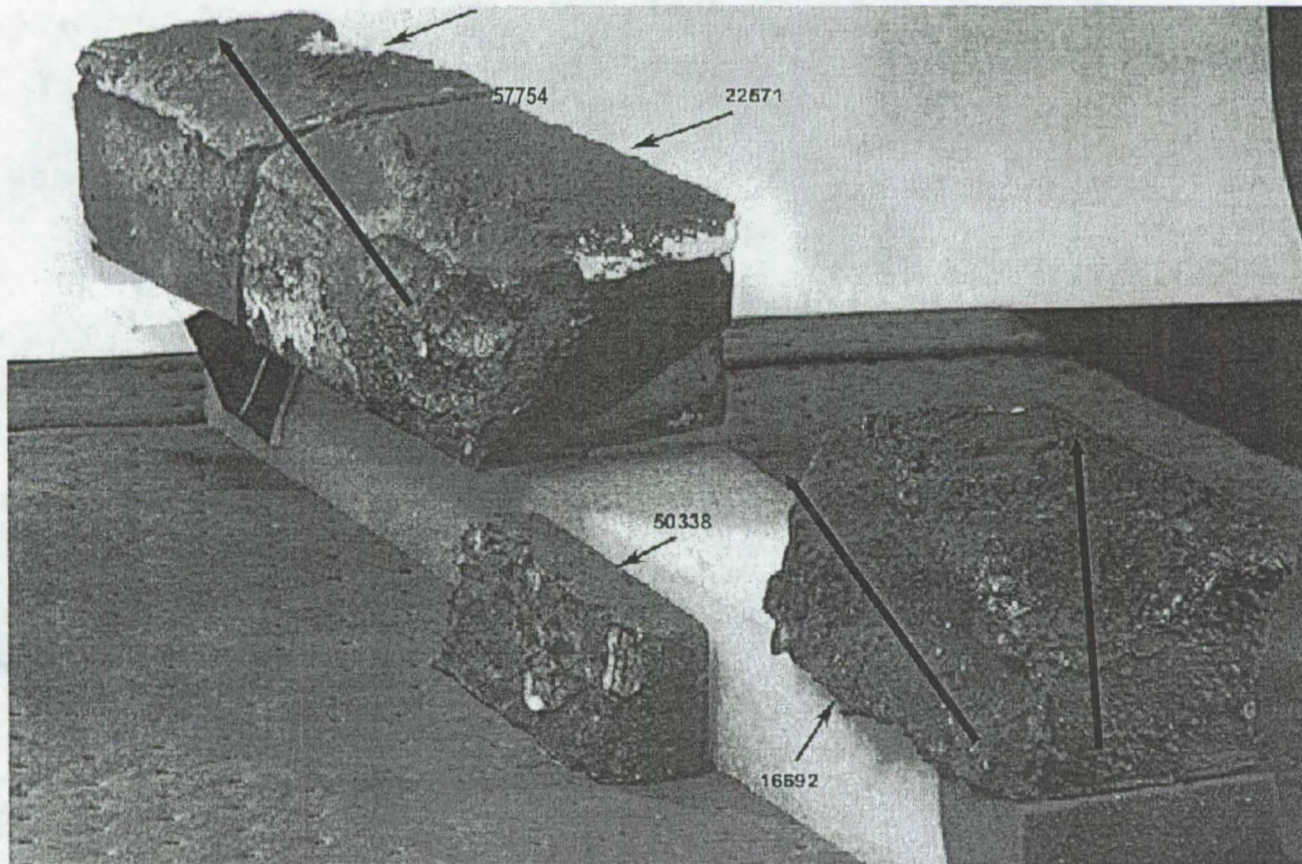
Reconstructed View of Lower C/P 9 Tile

Slumping and erosion patterns suggest plasma flow across the carrier panel tile (from 8 toward 10)

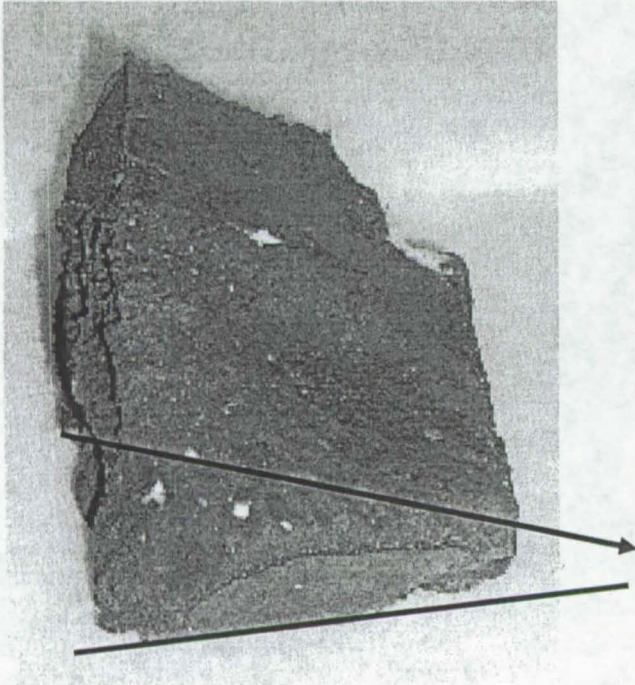
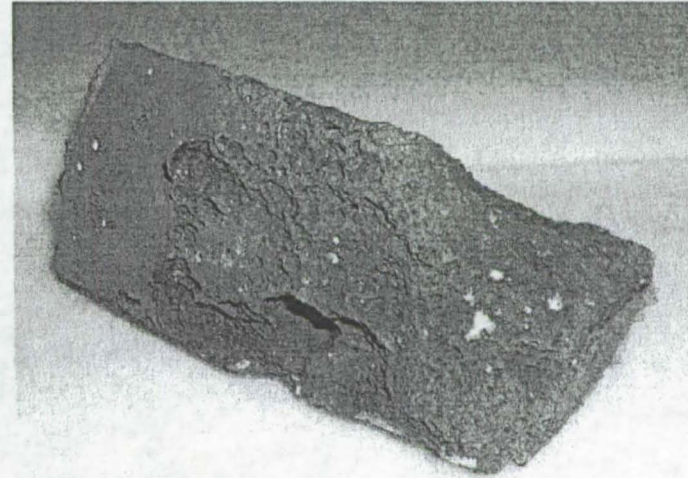
Item 50336 (V070-199715-074)

**Slumping and erosion patterns suggest plasma flow
out of leading edge cavity (consistent with vent)**

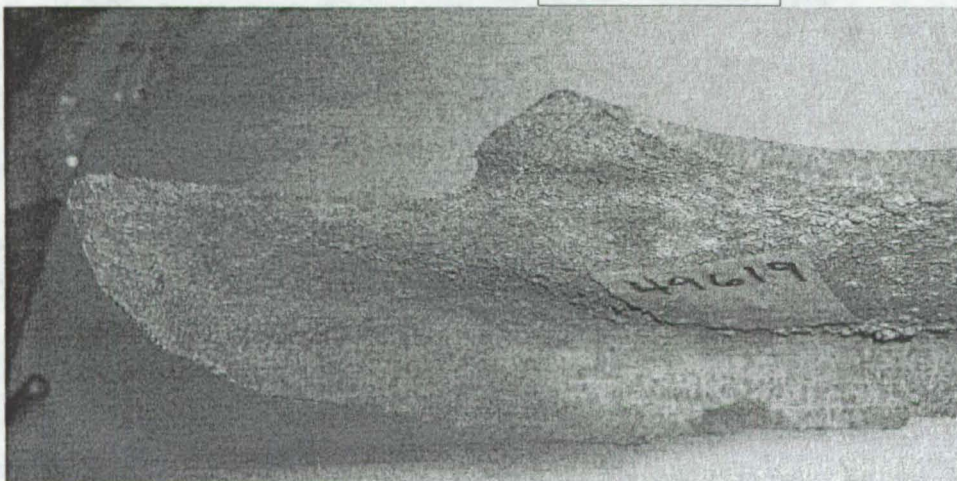
Item 49619

Erosion on Panel 8 Upper Inboard Rib

Close-ups of knife edge,
note fibers not visible on
internal surface of panel
due to deposits.

Rib tapers from design
thickness of .365" to .05".

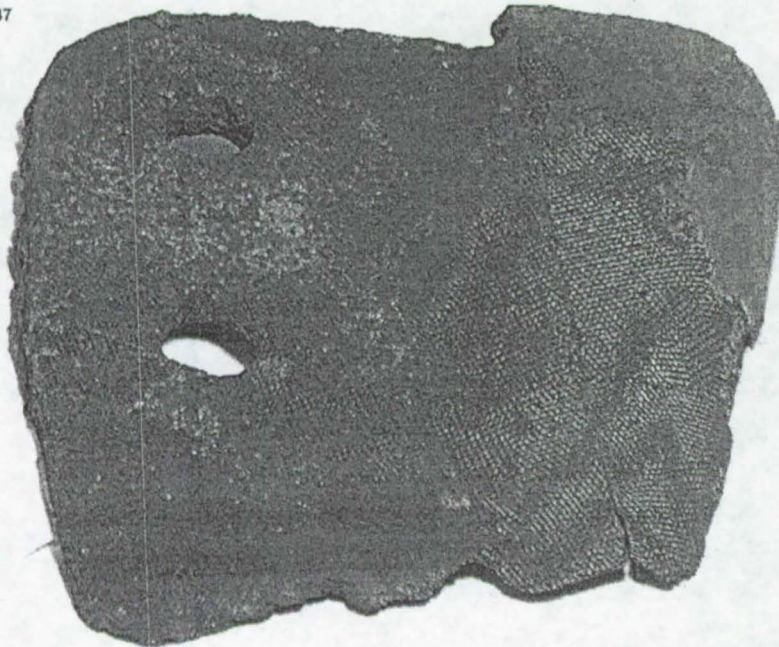
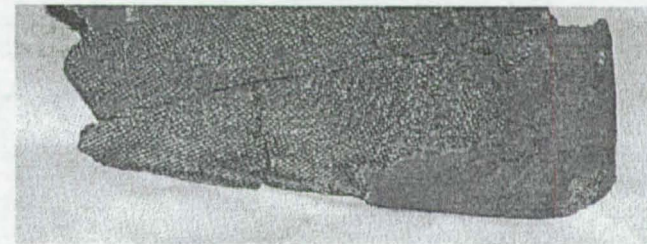
Erosion on Gap Surfaces of Panel 8 Outboard Lug & Matching Heel Piece

Lug fragment tapers from design thickness of .499", to a Knife Edge with a minimum thickness of 0.063"

- Matching eroded plies between items 24724 and 58291, shows heat flow external to the panel while panel heel and lug were attached
- Slag deposits at lug attach points - evidence that slag deposited after lug no longer attached to fitting
- Inconel bushings missing at holes

Heel fragment tapers from design thickness of .233", to a Knife Edge with a minimum thickness of 0.052"

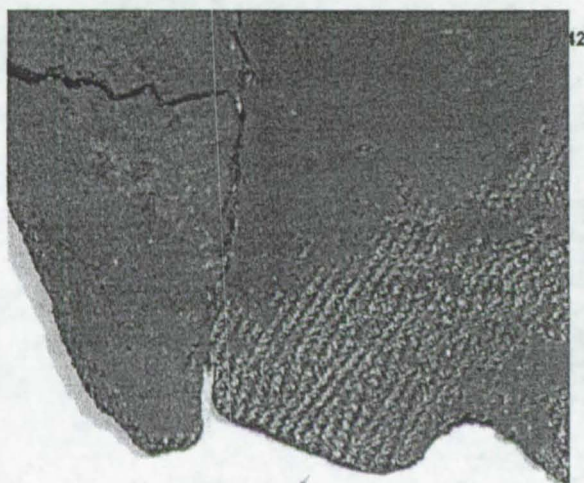
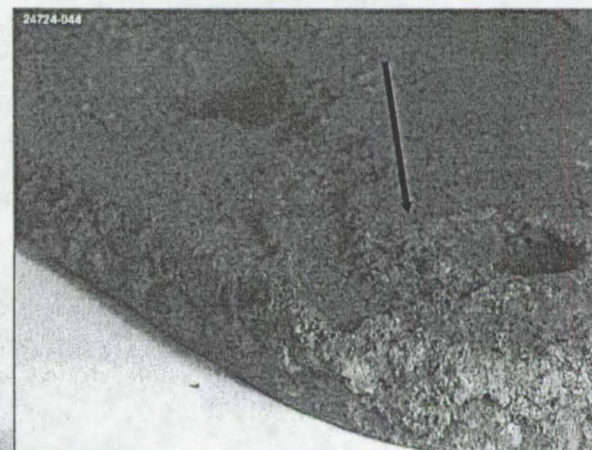
Fracture match of Items 24724 and 58291,
showing surfaces internal to the panel

Close-up of erosion
on internal surface
of panel lug, note
direction upward
and inwards
towards spar.

Close-up of fracture match, note ply erosion
only on the lug fragment. Evidence suggests
that internal surface of lug was eroded after
heel fractured off.

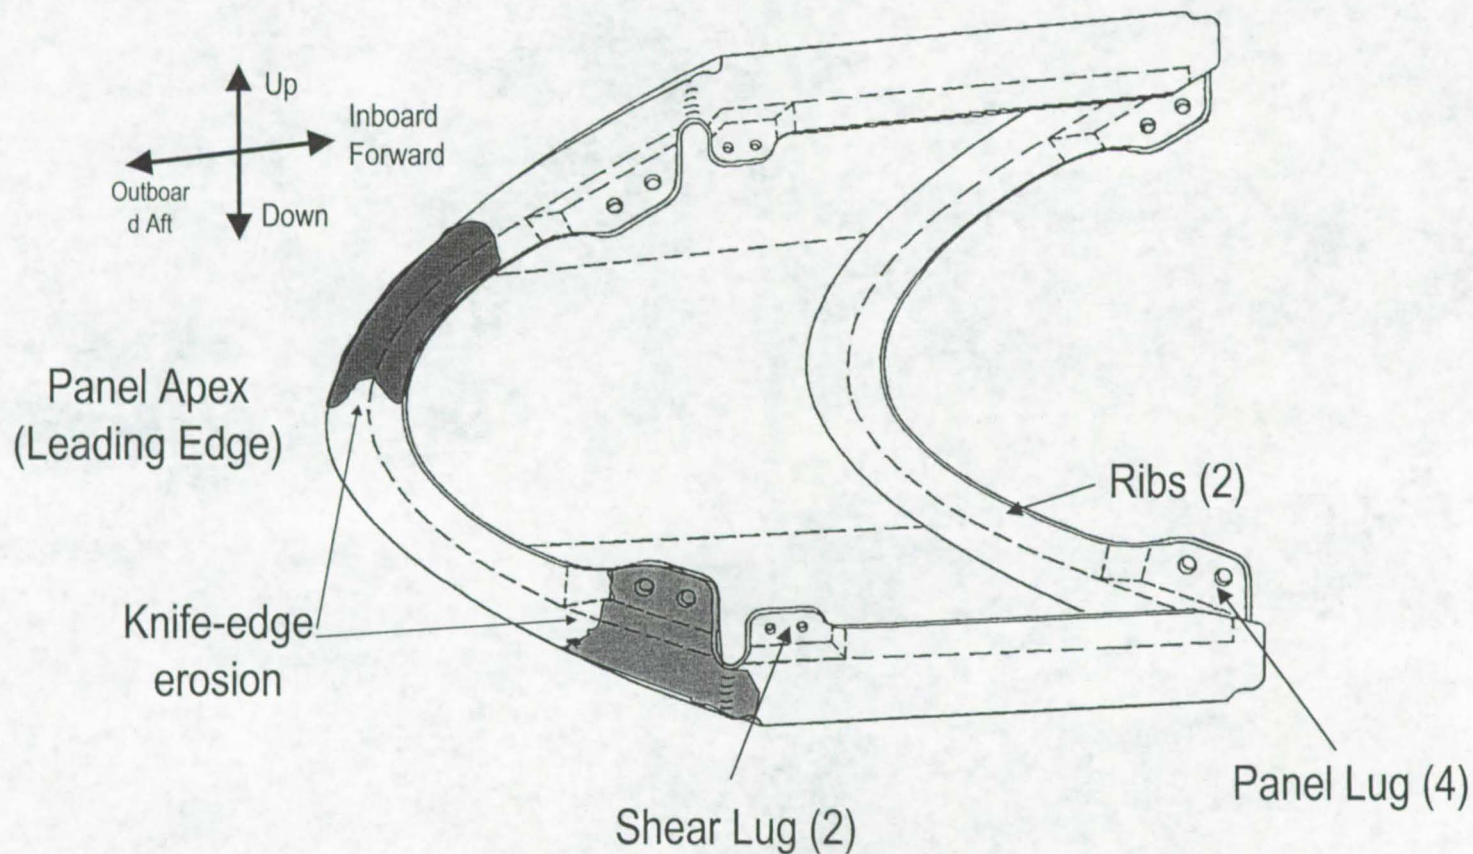
RCC Panel 8 Erosion Features

Erosion indicates prolonged exposure to plasma heating

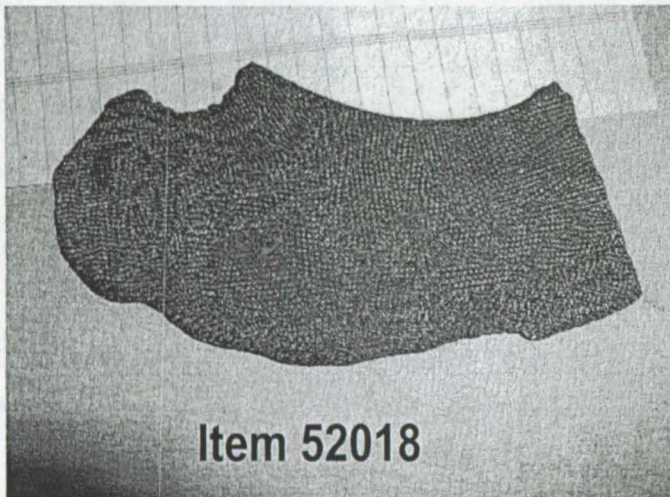
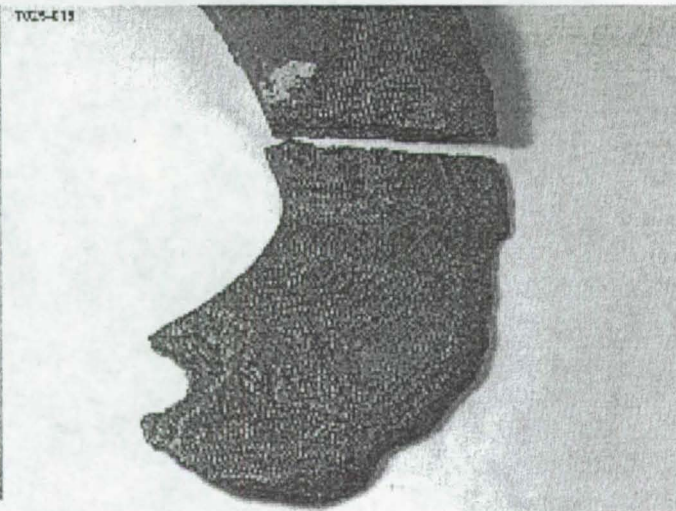
Erosion on Panel 9 Upper Inboard Rib

7025 to 52018
interface
shows severe
thermal
erosion –
thickness
ranges from
0.270 to knife
edge of 0.040

7025 internal side shows
presence of slag deposits

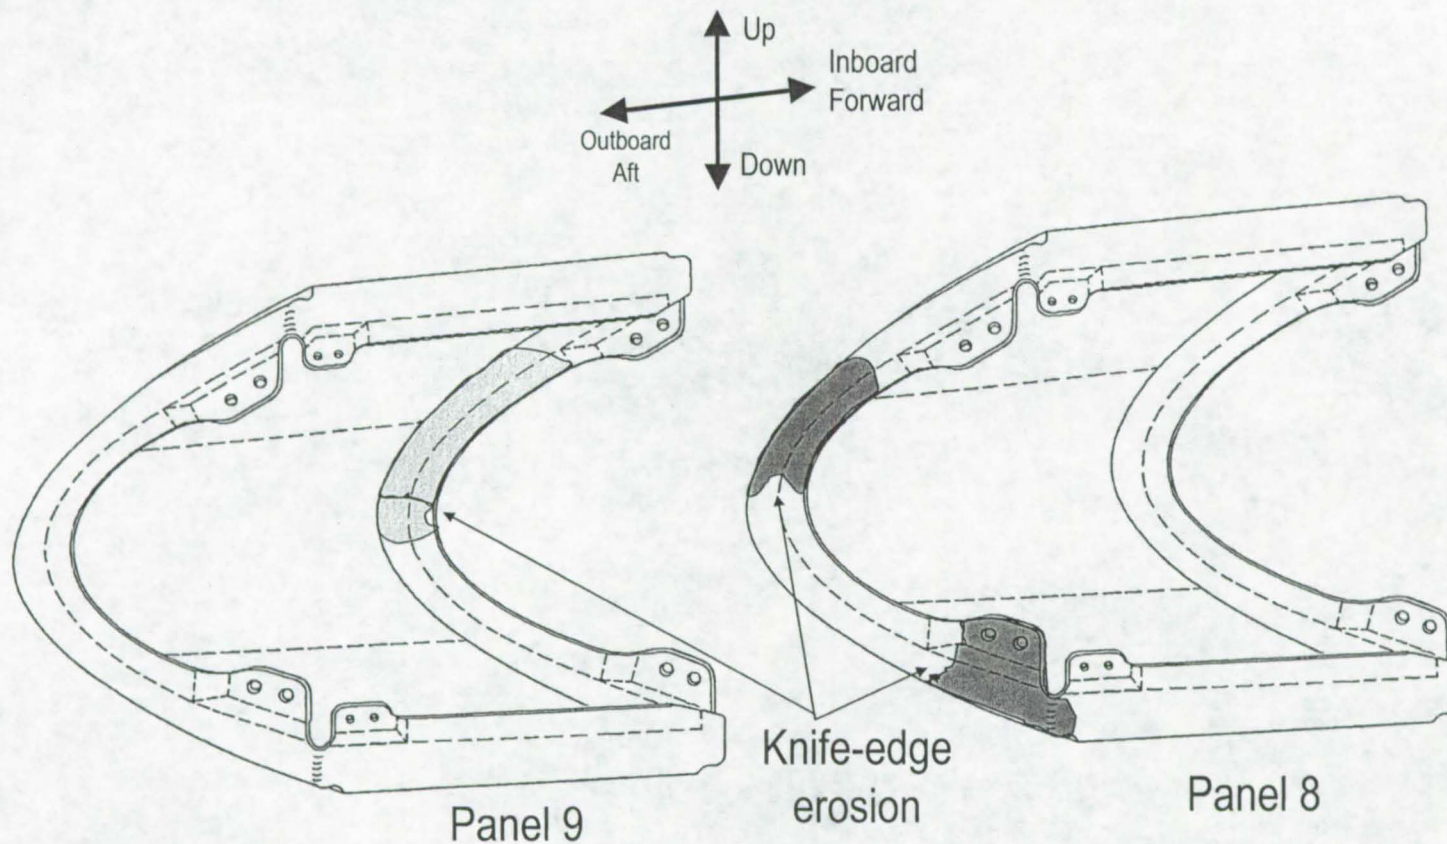
RCC Panels 8 & 9 Erosion Features

Erosion indicates prolonged exposure in the panel 8-9 joint area.

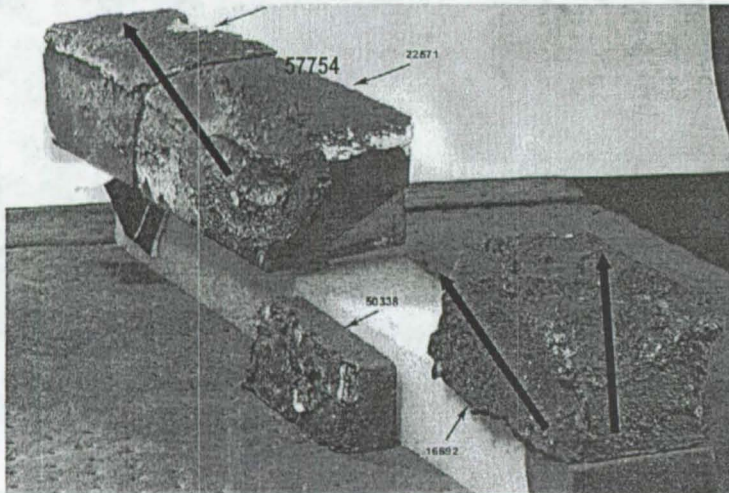
Slumping Source for Carrier Panel 9 Tile was Revealed

Slumping and erosion patterns suggest plasma flow across the carrier panel tile (from 8 toward 10)

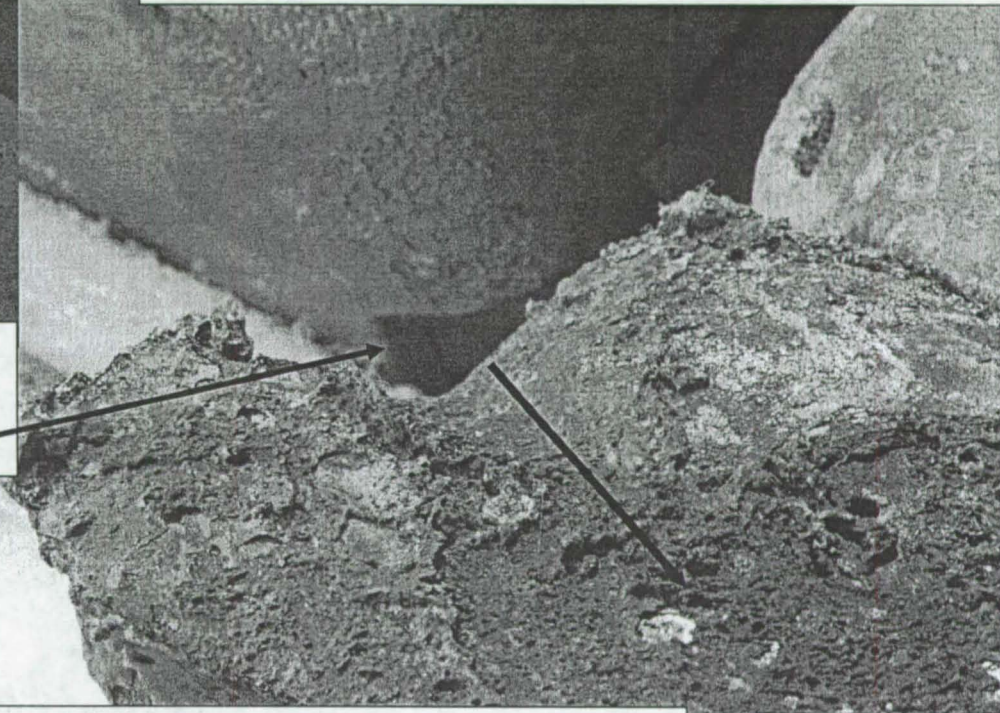
Slumping of C/P 9 Tile #1 Corresponds with Design Slot in Corner of RCC Panel 8

Evidence of Hot Gas Flow Exiting Design Slot Indicates Significant Breach Was Into Panel 8

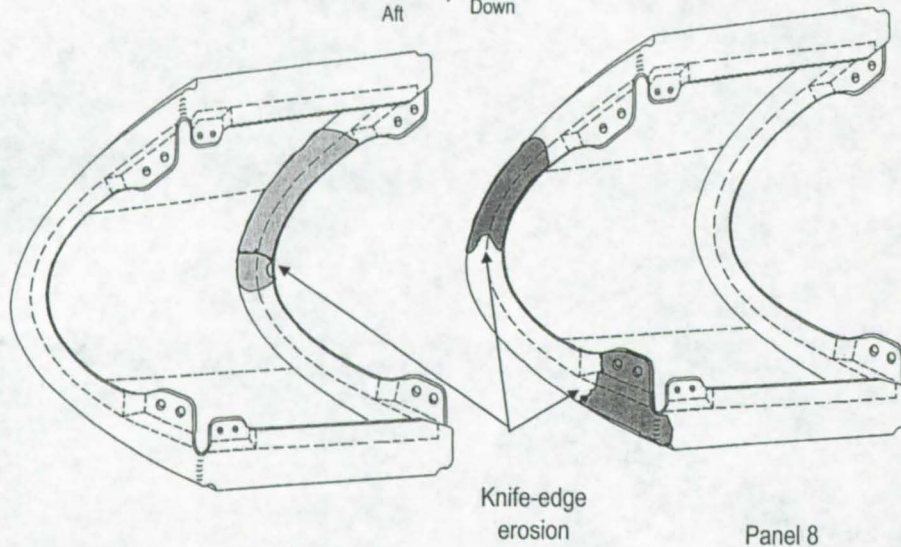
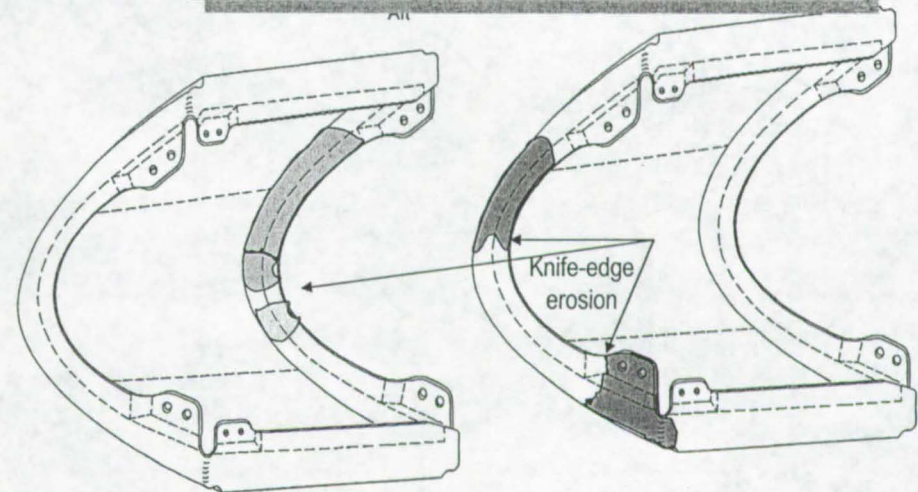
RCC Panels 8 & 9 Erosion Features

Erosion indicates prolonged exposure in the panel 8-9 joint area.
Additional effort required to properly "read" the erosion

Erosion indicates prolonged exposure on:
Forward faces of panel 8 aft rib
Forward faces of Panel 9 forward rib

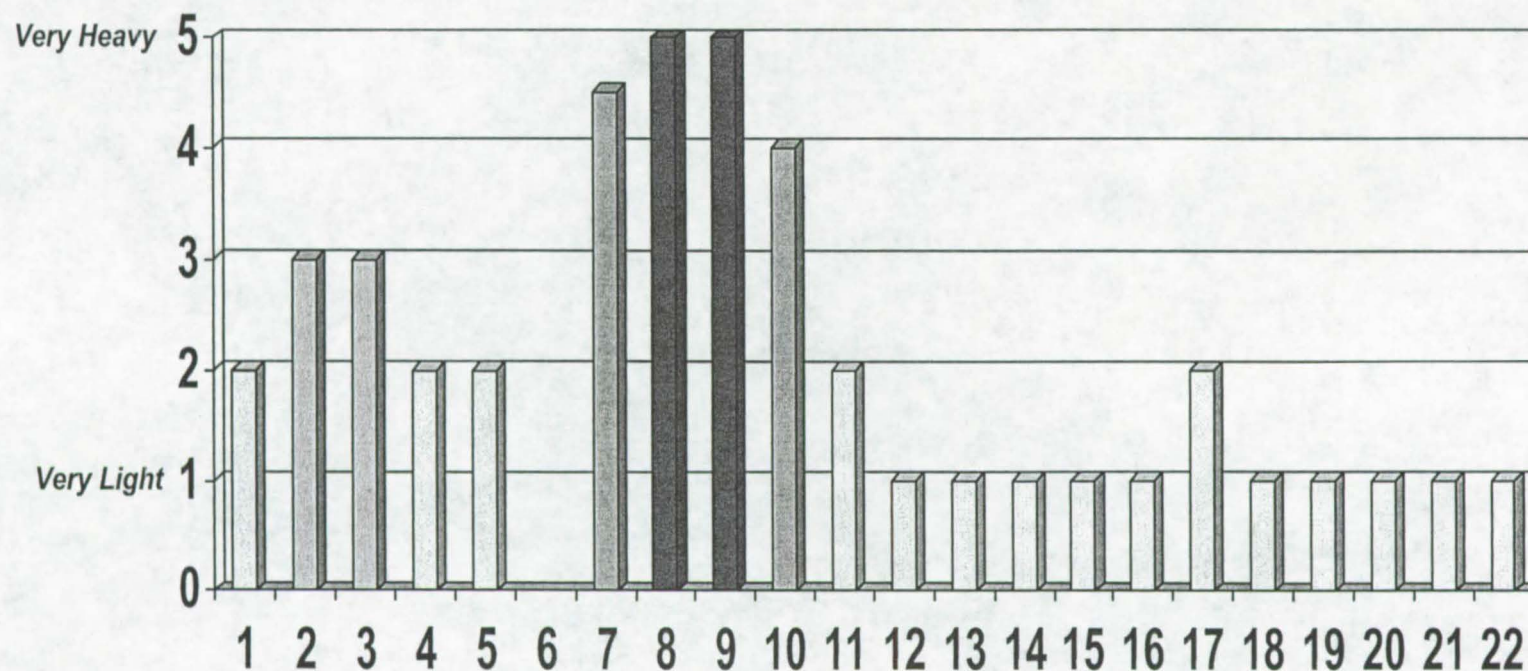
Relative Metallic Deposition on L/H Wing Materials

**Distribution of metallic deposition volume
was centered around panels 8 & 9**

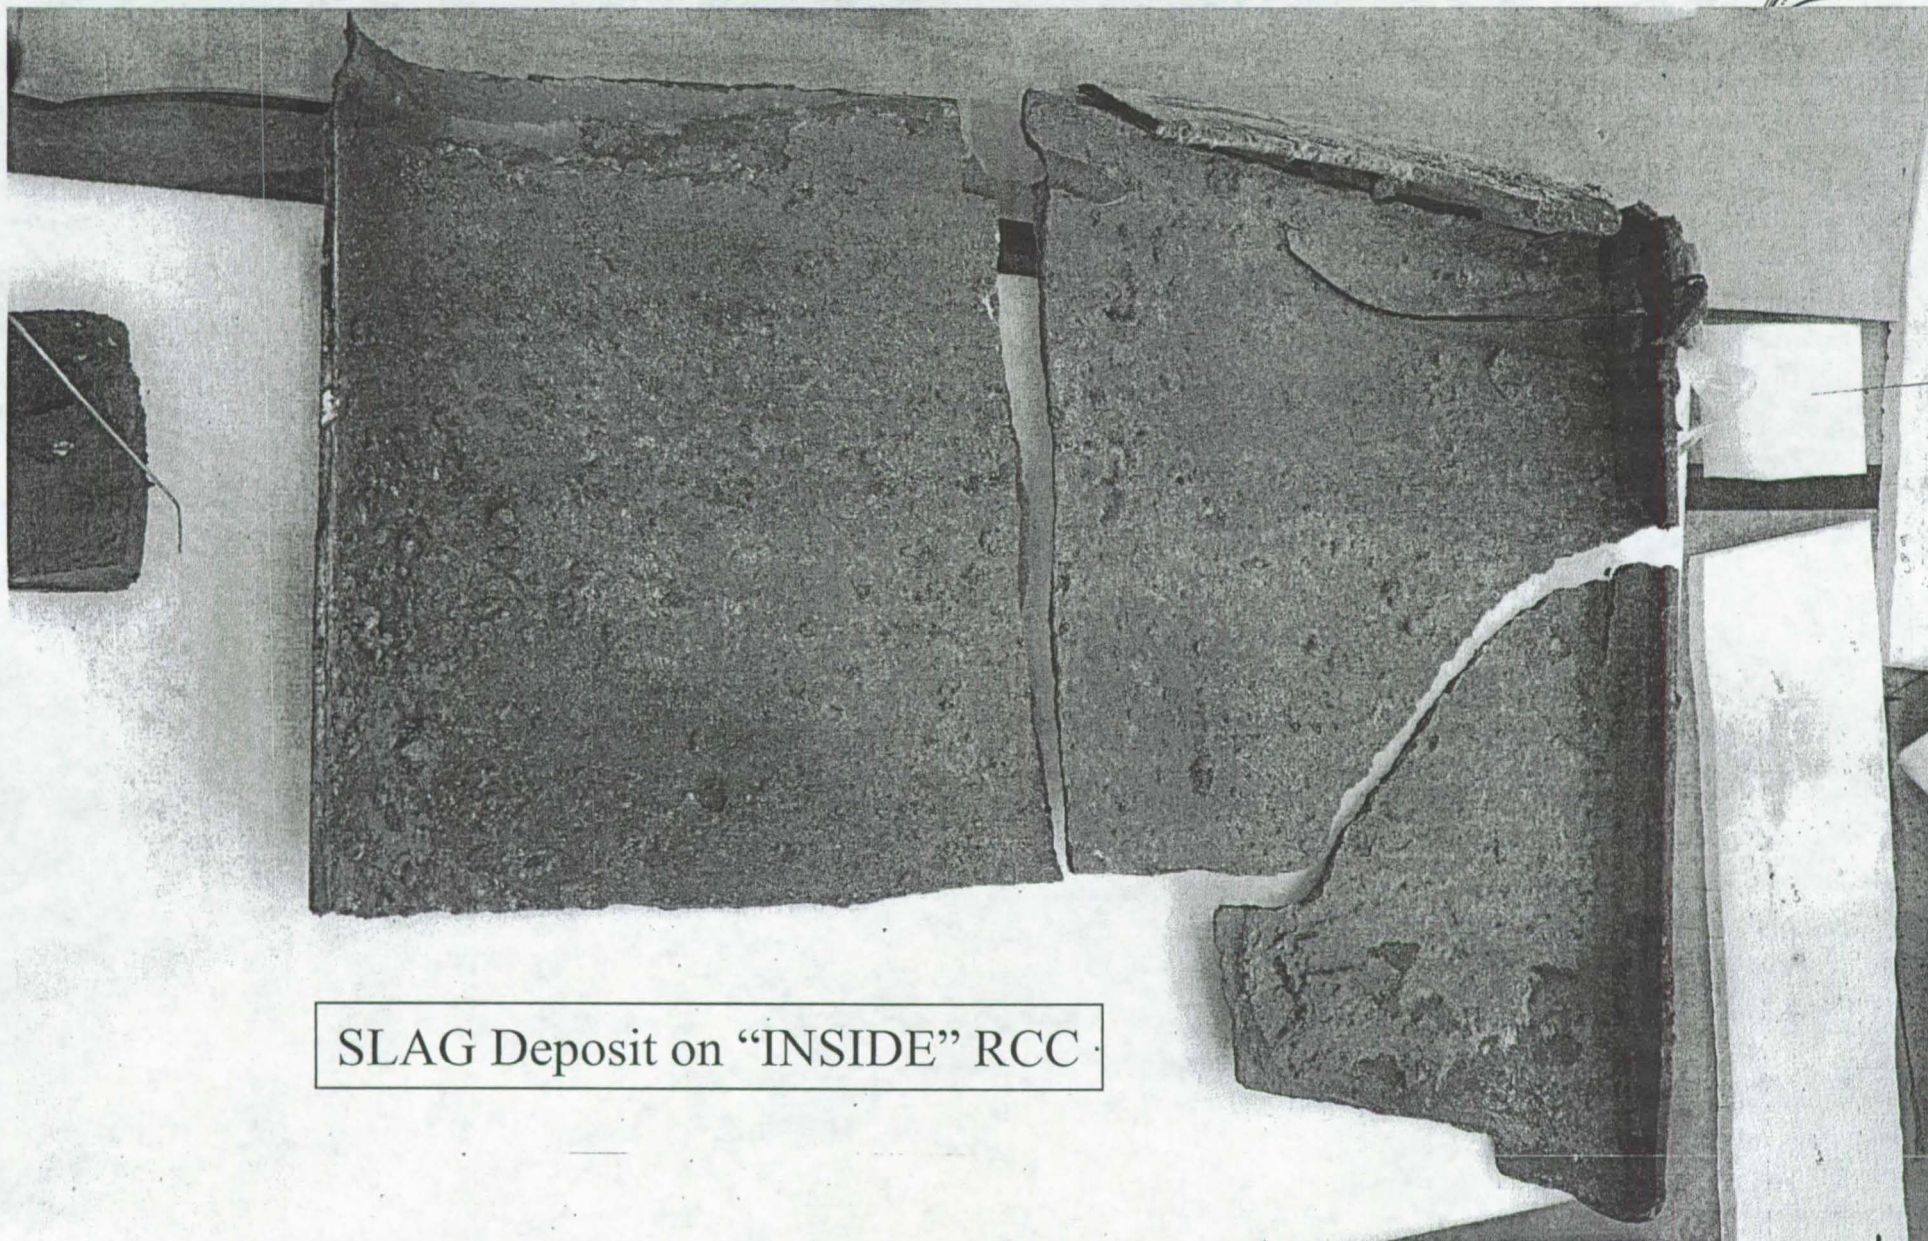
Slag Deposit Example, LH RCC 8

SLAG Deposit on "INSIDE" RCC

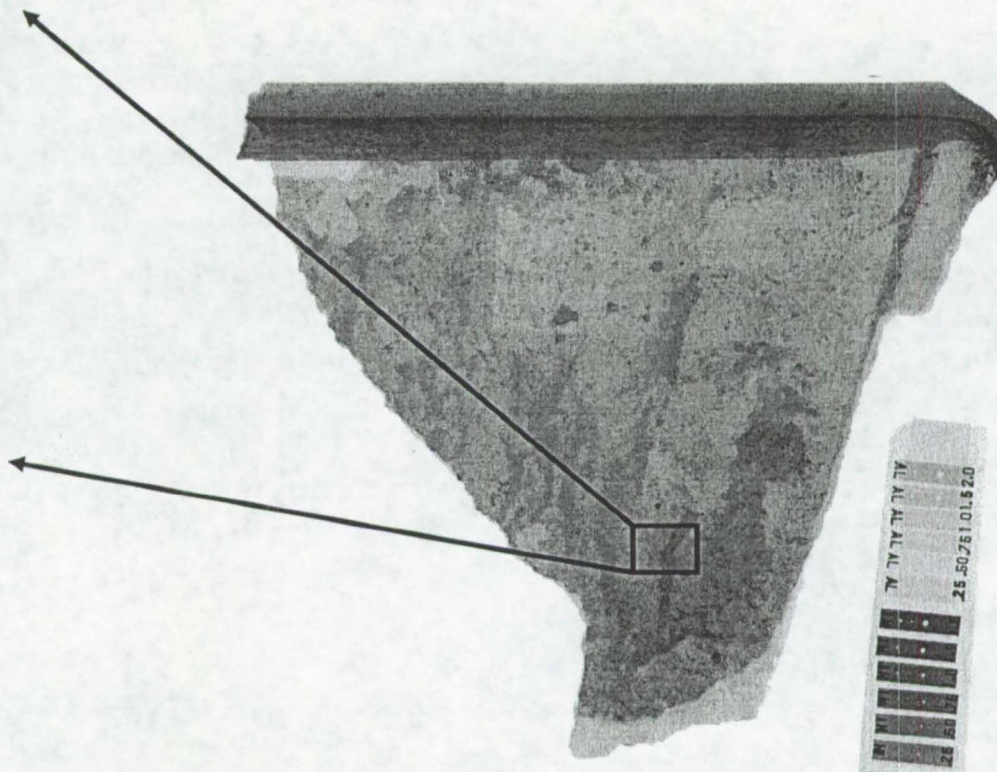
Slag Item 43709, Sample 2A1

LH RCC 8 – Slag Feature: Thick Tear Shaped

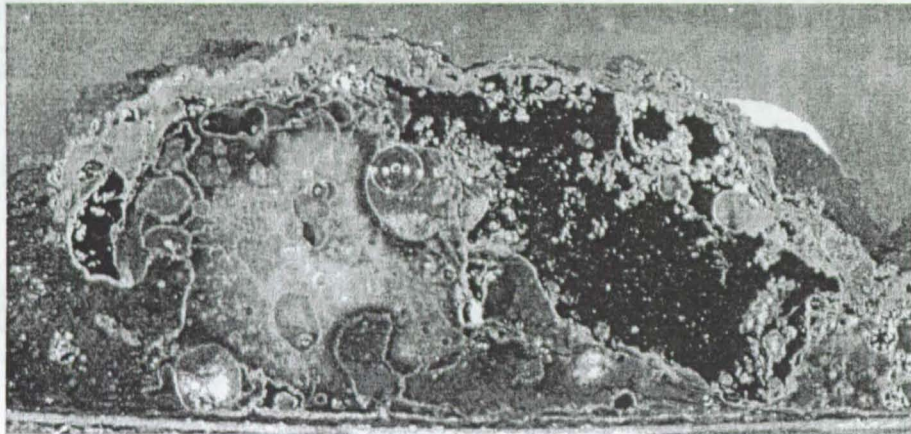
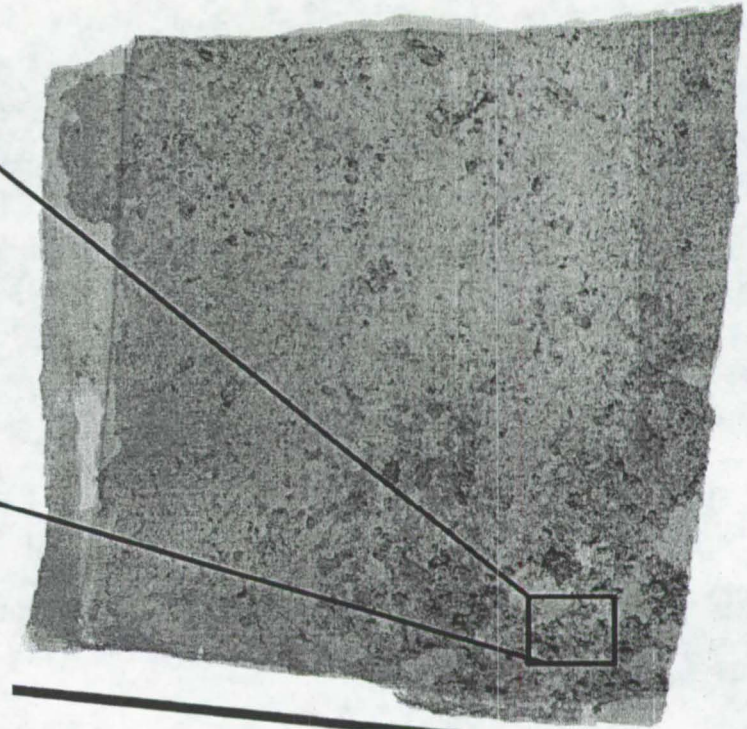
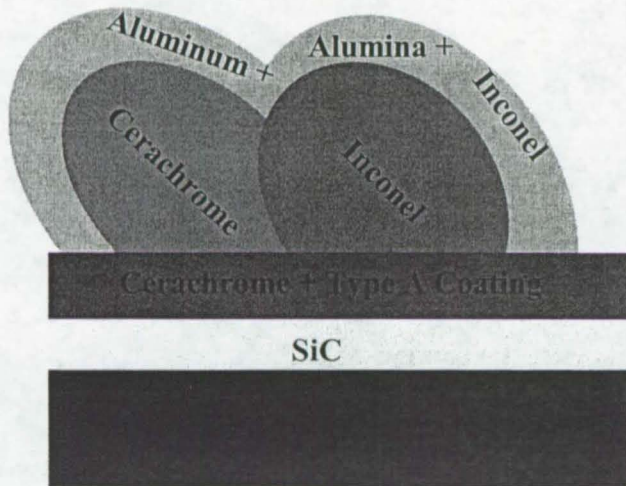
Slag Item 2200, Sample 6A1

LH RCC 8 – Slag Feature: Thick Globules

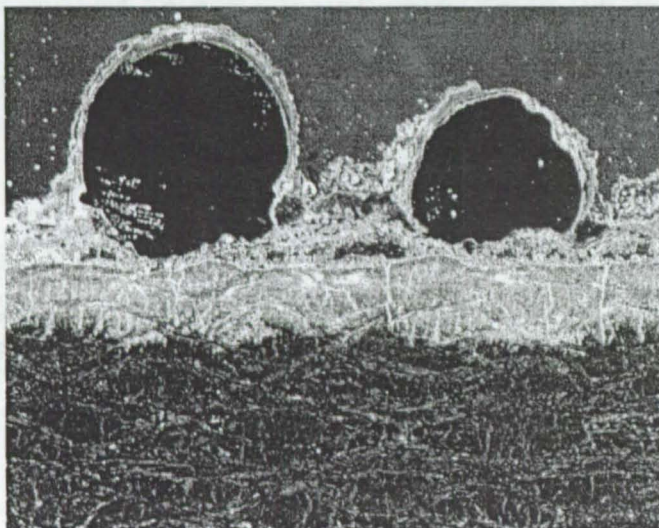
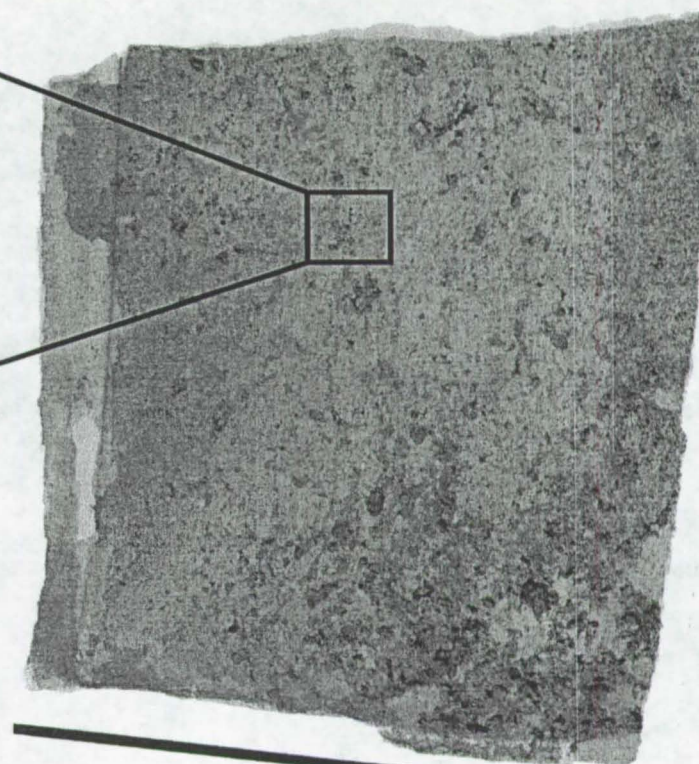
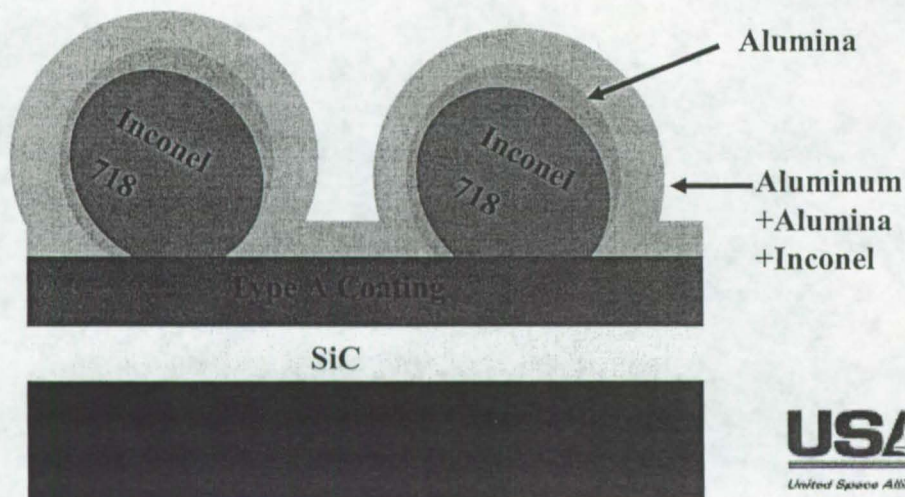
Slag Item 2200, Sample 6C1

LH RCC 8 – Slag Feature: Spheroids

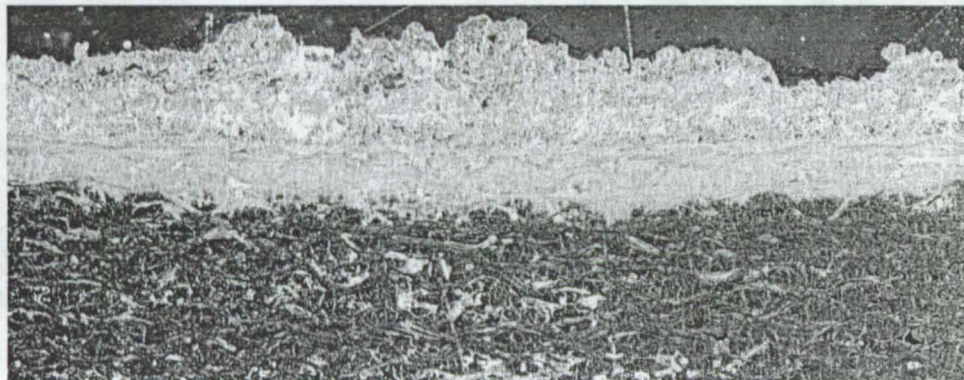
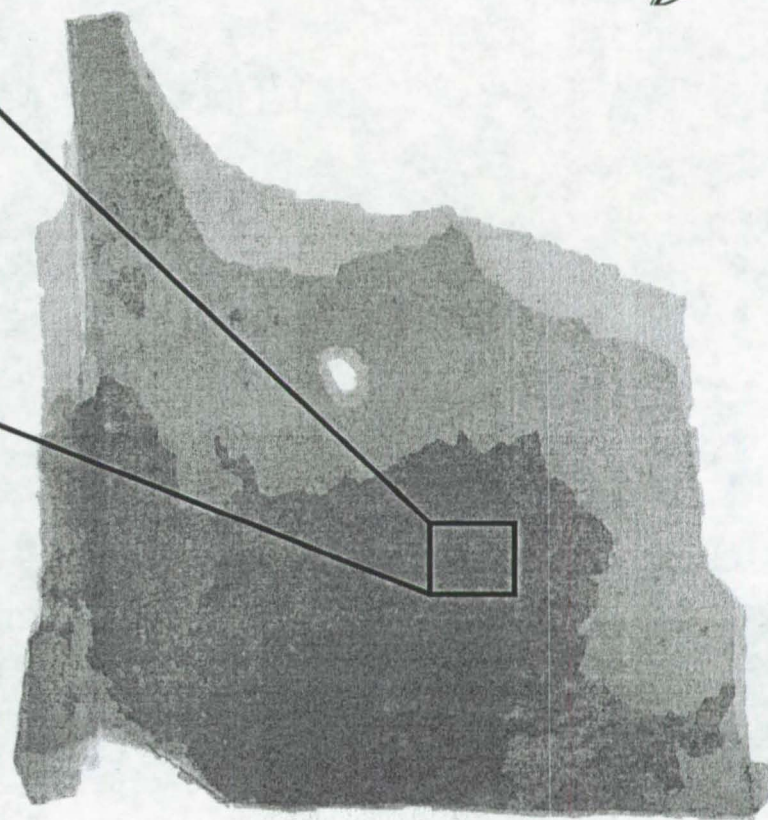
Slag Item 16523, Sample 4A1

LH RCC 8 – Slag Feature: Uniform Deposit

Cerachrome+Aluminum+Inconel+Alumina

Aluminum+Inconel+Cerachrome+Type A Coating
